Fusion-Crete®

Pool Deck Restoration

Sheraton Steamboat Resort

SHERATON STEAMBOAT RESORT POOL DECK RESTORATION

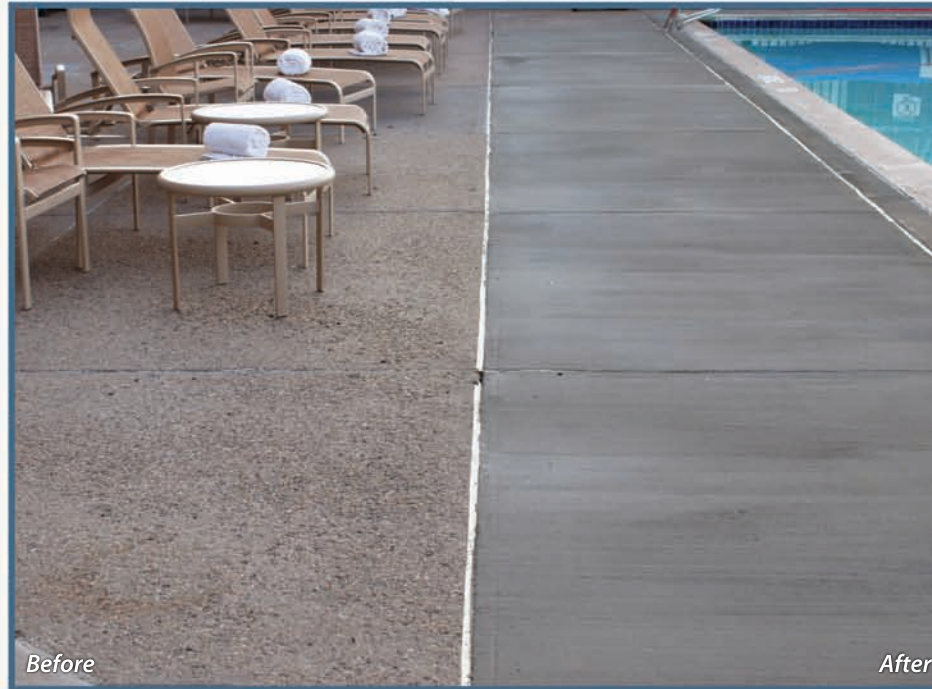
The pool is built into a structural concrete deck with a four-inch topping slab totaling 3840 square feet. The topping slab, being 20 years old, displayed several types of damage due to water intrusion, freeze-thaw cycles to an extreme degree, exposure to UV rays, snowmelt agents, and snow and ice removal by steel blades and ice bars. A few details of the existing damage include:

- Fifty percent of the panels were sound concrete with the top surface spalled to the larger aggregate.
- Most or all of six panels displayed areas of deep rot, spalling, and uncontrolled cracks.

- Other panels contained a total of 150 linear feet of uncontrolled cracks that had been ground with a crack-chaser and filled with self-leveling urethane caulk.

- Sixty-seven linear feet of the edge of a ten-inch wide retaining band for the pool coping stone was deteriorated and filled with self-leveling urethane caulk.

- Near the restroom for the pool there was an irregularly shaped area (approximately 100 square feet) in which water would collect into a puddle due to the failure of a structural member beneath the deck. The repair of the structural member left the elevation of the area approximately one inch lower than its original elevation, causing water to puddle and freeze in winter posing a safety hazard.

- Control joints between panels were filled with urethane caulk from ¼ inch to 1 inch wide that will not accept a cementitious finish coating.

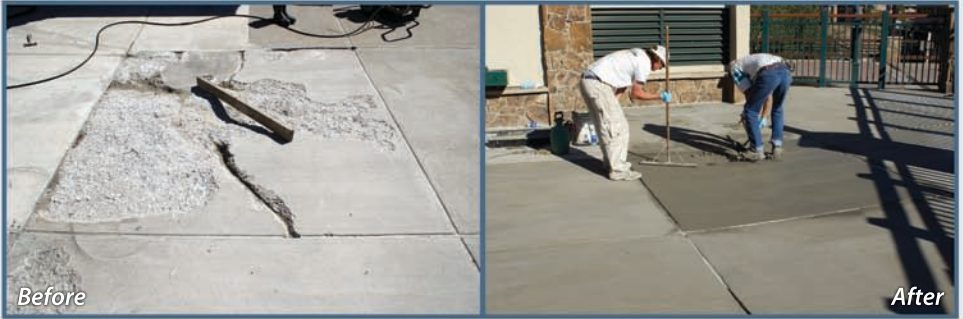
The topping slab has been stabilized and restored and the pool deck is up to par with the standards of the lodging facility. A slurry coat over the repairs has created the consistent appearance of a new concrete deck. The pool area is renewed and revitalized.

The profiles of the deck were restored and ready for the finish coat. To give the finish coat a lighter shade of gray concrete color, 25% of the cement portion of the mix was white Portland. After priming with water from a garden sprayer the slurry mix was spread onto the panels with a squeegee and finished with a light-weight polyester broom.
