ABS Crack-Stitching System... The Hidden Solution

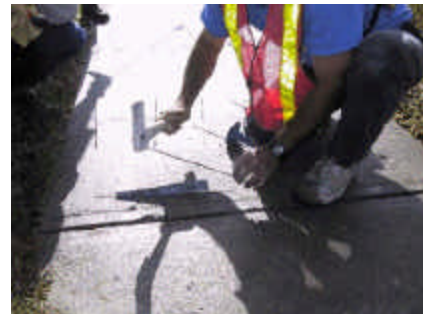
CRACK STITCHING: Galvanized steel blades being installed before Fusion-Crete® is applied.

Crack stitching is an effective means of stabilizing an existing crack and prevents eventual movement of the crack from causing delamination of an overlay system. By pinning the crack together in three dimensions, the movement of the crack is limited to rotation only. The purpose is to prevent the crack from moving apart, sideways, up or down.

1. A series of saw cuts are installed perpendicular to the crack to a depth of approximately half the thickness of the slab. Saw cuts must be spaced ten to twelve inches apart.
2. A corrugated galvanized steel blade is installed in the saw cuts.
3. Fusion-Crete® slurry is then applied to fill the remaining voids in the saw cut and the crack itself.
